## Test site 1 caravan site in Dorset.

## The situation

### The problem

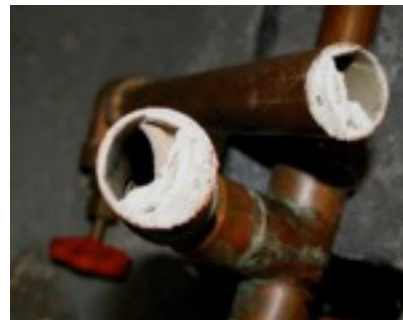
These pipes show the extent of the limescaling problem on this holiday site

Pipes on this site have had to be replaced regularly due to vast scale problems. In one location a 32mm pipe has been reduced by scale down to roughly the capacity of 15mm pipework.

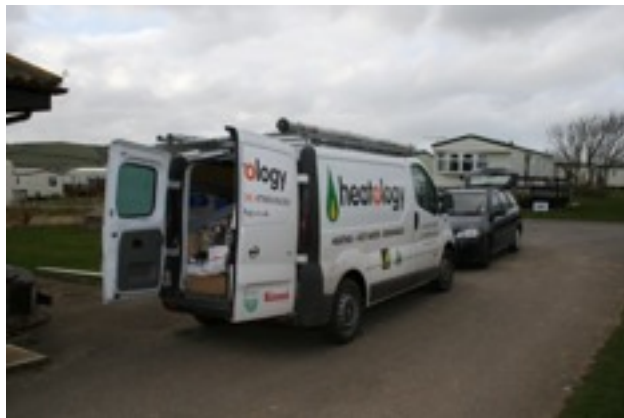
Heatology installed the new Rinnai hot water heaters along with the AQUABION®s to guarantee 100% efficiency.

The contractor Norman Squire of Heatology Ltd installed the Riannai hot water heaters, thermal stores along with the solar thermal on the roof. The AQUABION® units were also installed by Norman, at the same time as the new heaters.

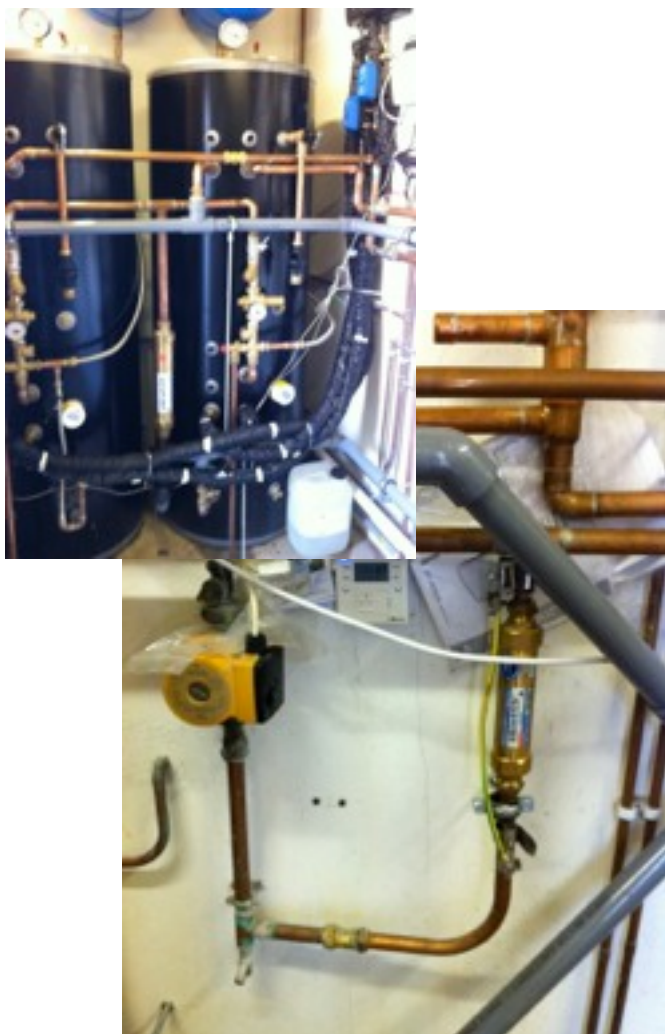
The AQUABION®s installed on the mains and on the Secondary Return

An AQUABION® H40 was installed on the supply pipe as well as an AQUABION® S20 on the secondary return, after the pump. This solution was not only supposed to provide a better protection than previous technologies but also a better value for money.

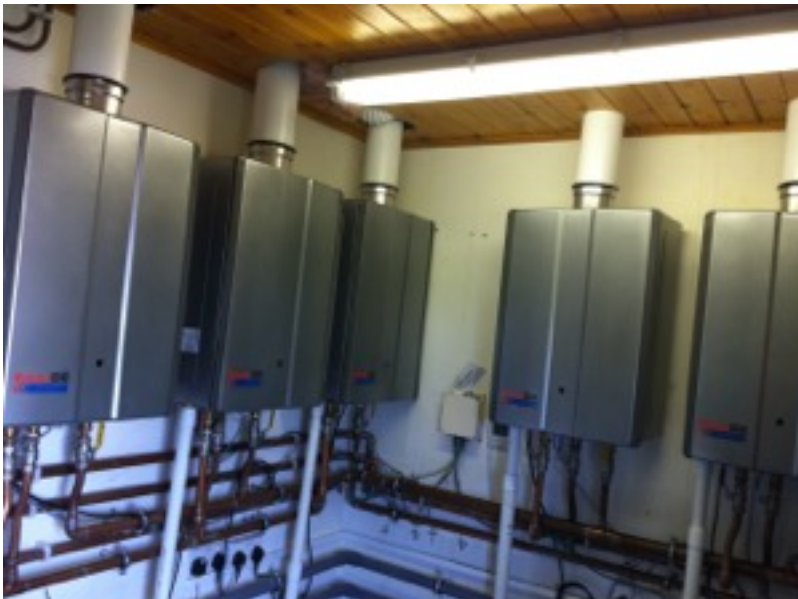
The advanced Rinnai hot water heaters control panels report no limescale, indicating they are running as efficiently as when they were installed.

The advanced Rinnai hot water heaters have an early warning system. Once the heat exchanger starts to scale up the boiler will detect the drop in efficiency and display an error code.

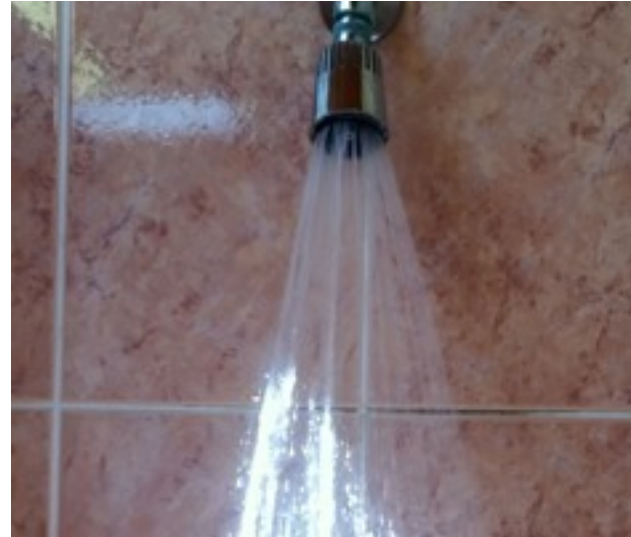
The showers no longer need weekly de-scaling

The shower heads no longer need the weekly descaling and the boilers have worked very well season.
