## Test site 4 the nursery in Durham

# The situation

## Test site 4 the nursery

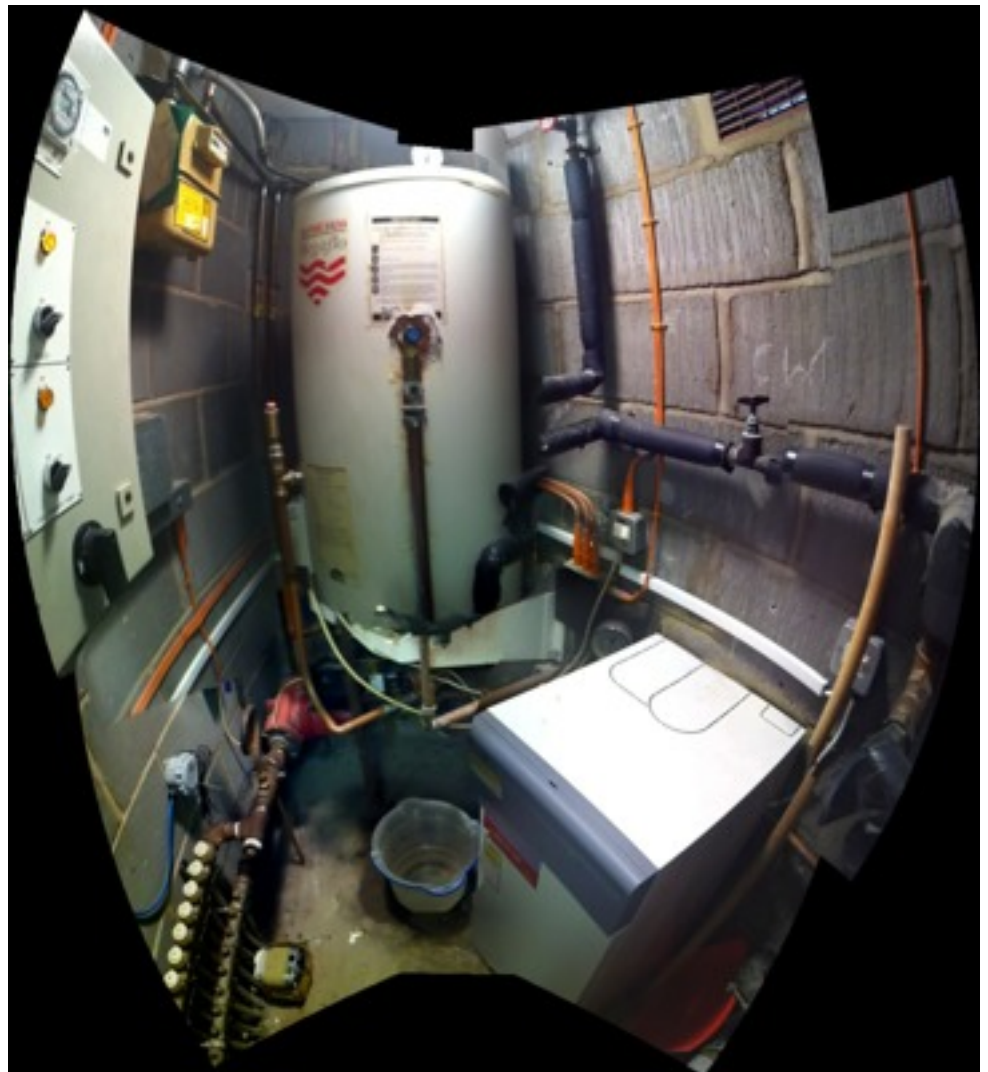
Inside the boiler room shows the Megaflo which even though it is only 5 years old can no longer function due to limescale!

The site has been plagued by problems during its short life due to the very high hardness levels (in-excess of 500ppm hardness). The existing Megaflo that was installed 5 years ago has scaled up to such an extent that it has been decided to remove it in favour of a Rinnai system protected by AQUABION®.

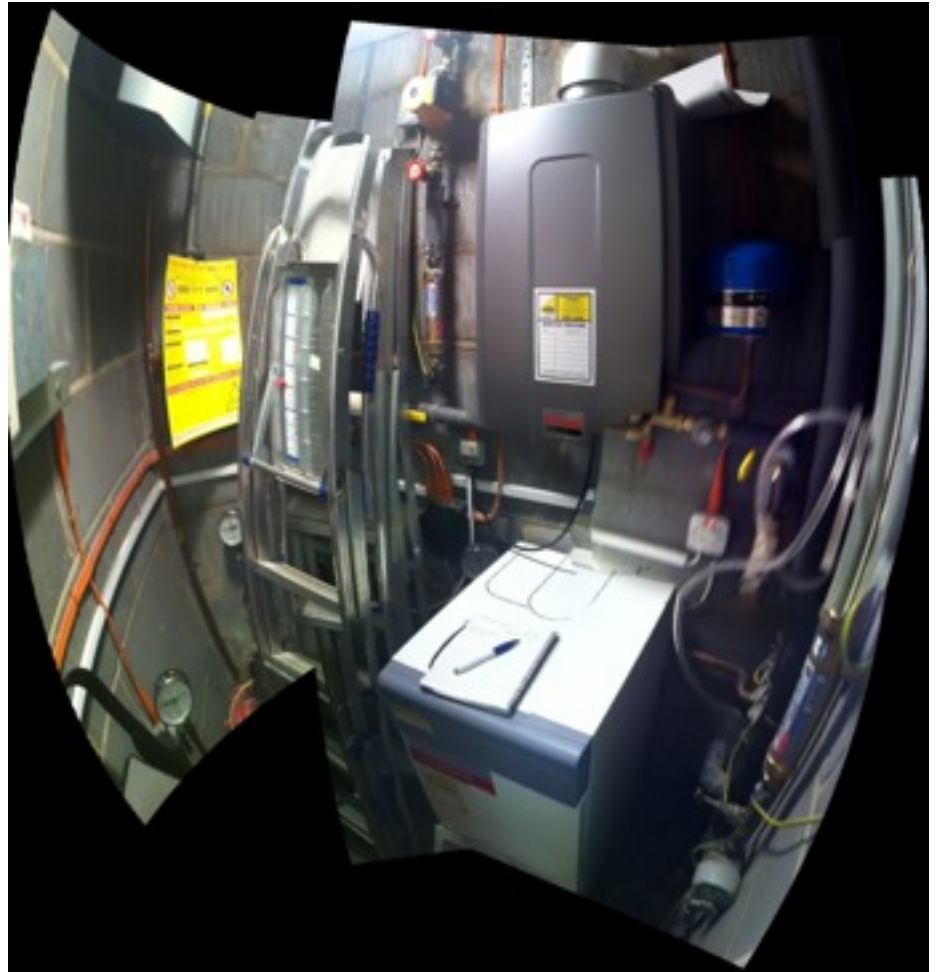
The boiler room now has more space because of the compact nature of the Rinnai water heat and the AQUABION® limescale solution.

An AQUABION® S20 was needed on the mains as well as an AQUABION® S20 on the secondary return, after the pump.
